SUBJECT: EQUIPMENT FURNISHINGS – COCKPIT ADDITIONAL ELECTRICAL SUPPLY – STATIC INVERTER – CAPACITOR C306 REPLACEMENT.

TRANSMITTAL: Service Bulletin 1830-25-37 Initial Release (Revision 1)

SERVICE BULLETIN

Instructions for Part Number 1-002-0102-1830, Model Number 2A350-1AS-1830

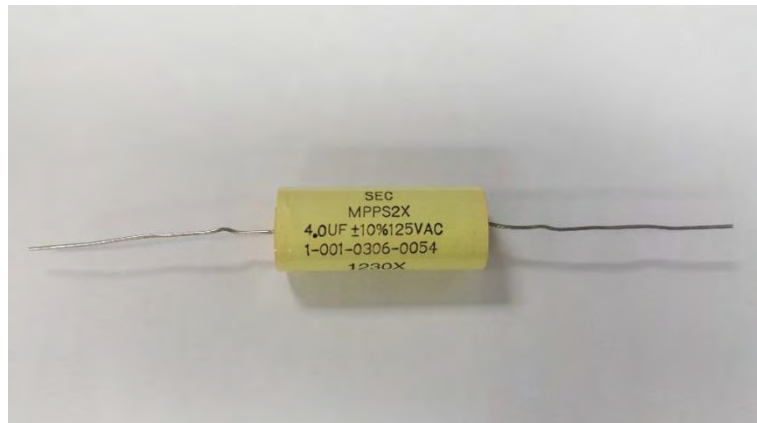
Analysis conducted by Avionic Instruments, ACI Technology INC, and CALCE, has determined that a specific manufacturer's supply of capacitor C306 (AI² P/N 1-001-0306-0054) may experience failure. The replacement of this capacitor with the latest version of AI² P/N 1-001-0306-0054 will greatly reduce the likelihood of this condition. The replacement capacitors are supplied from a different manufacturer and are subjected to an additional quality screening.

The C306 capacitor requiring replacement will appear similar to the one shown in the figure below (Figure A). The key characteristic to identify the suspect supply of capacitor C306 is the MPPS2X code. The suspect capacitor supply will contain the following information printed on its side:

SEC
MPPS2X
4.0UF ±10%125VAC
1-001-0306-0054
XXXX

Figure A – Suspect supply of capacitor C306 (AI² P/N: 1-001-0306-0054)

10. Locate the capacitor (Figure 6). If the capacitor within the unit is similar to Figure A, remove and proceed to Step C.1. If it does not contain this capacitor, proceed to Step C.2.

1. Install the new capacitor in the location where the old capacitor was removed from. (Note: the new capacitor will be marked with a red dot) (Figure 6).
2. Reattach the Bridge Assembly using one (1) screw and washer to connect the bridge assembly to the front panel, and five (5) screws and washers to connect the bridge assembly to the base (Figure 5).
3. Carefully reattach the PCB to the three connection points. Ensure all three points are connected firmly (Figures 3 and 4).
4. Fasten the PCB to the unit using four (4) corner screws, and one (1) center screw. All screws in this step use washers (Figure 2).
5. Place the top cover back on to the unit.
6. Secure the top cover using three (3) top screws, two (2) rear screws and eight (8) side screws. All screws in this step use washers.

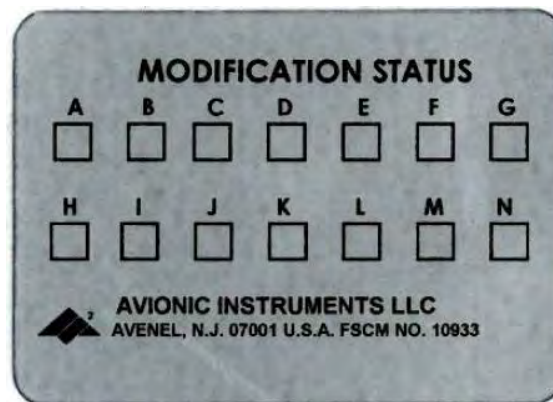
Figure B – Modification Status Label

Upon completion of the modification described in this service bulletin, a “Modification Status” label is to be added to the top cover of the unit (See Figure B). The label is to be marked to indicate the modification status as level “A”.

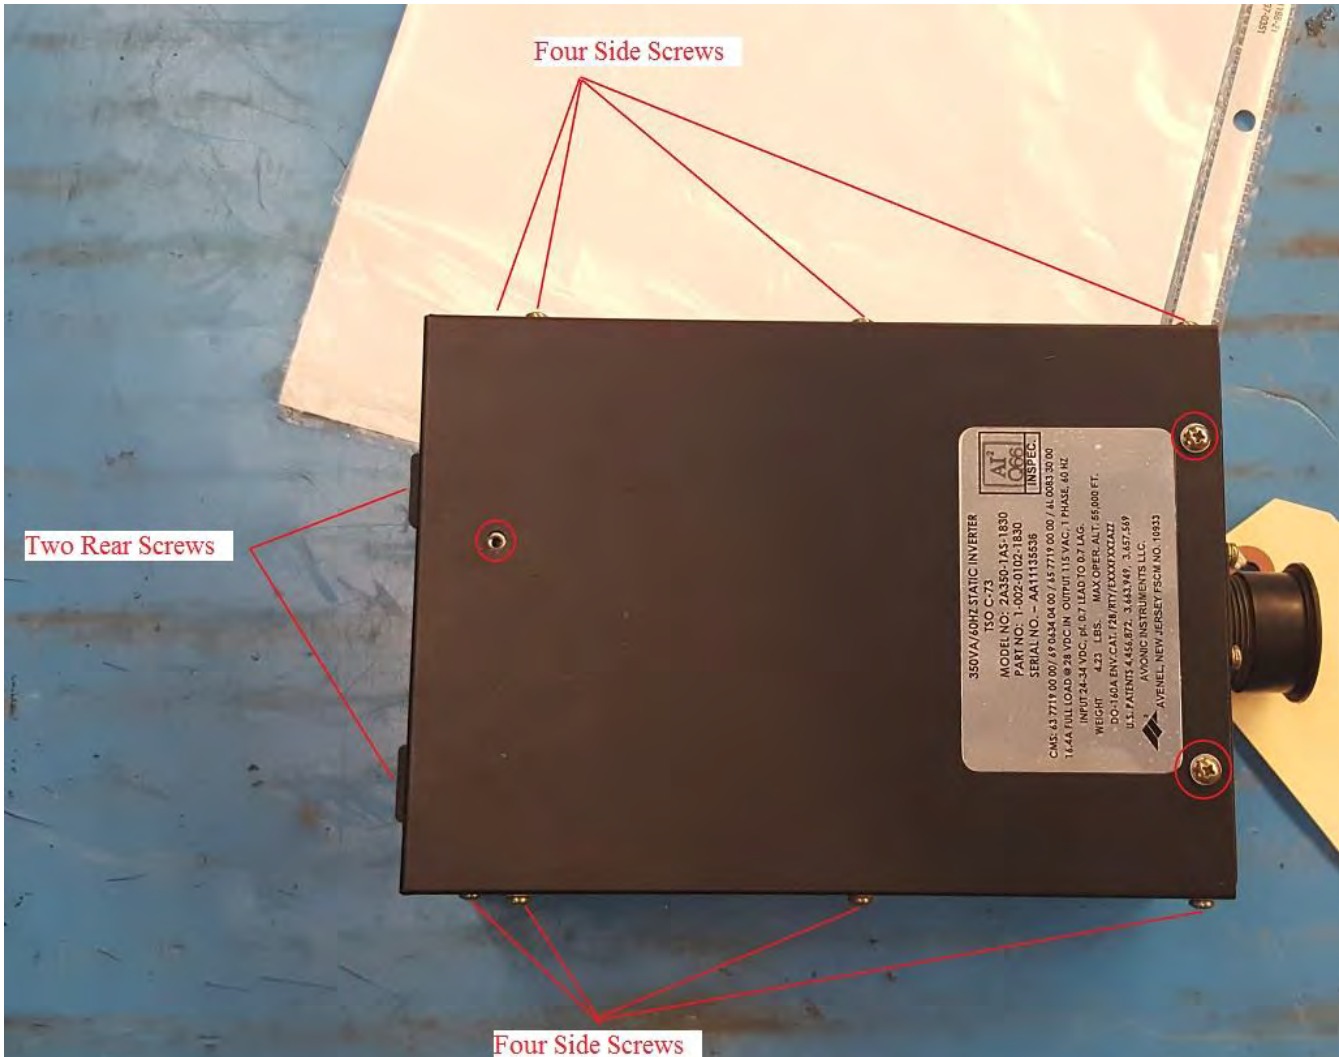
Figure 1 – Top Cover View (Exterior Screw Locations)

1. Remove three (3) top screws, two (2) rear screws and eight (8) side screws from the top cover of the unit. All screws in this step use washers (Figure 1).

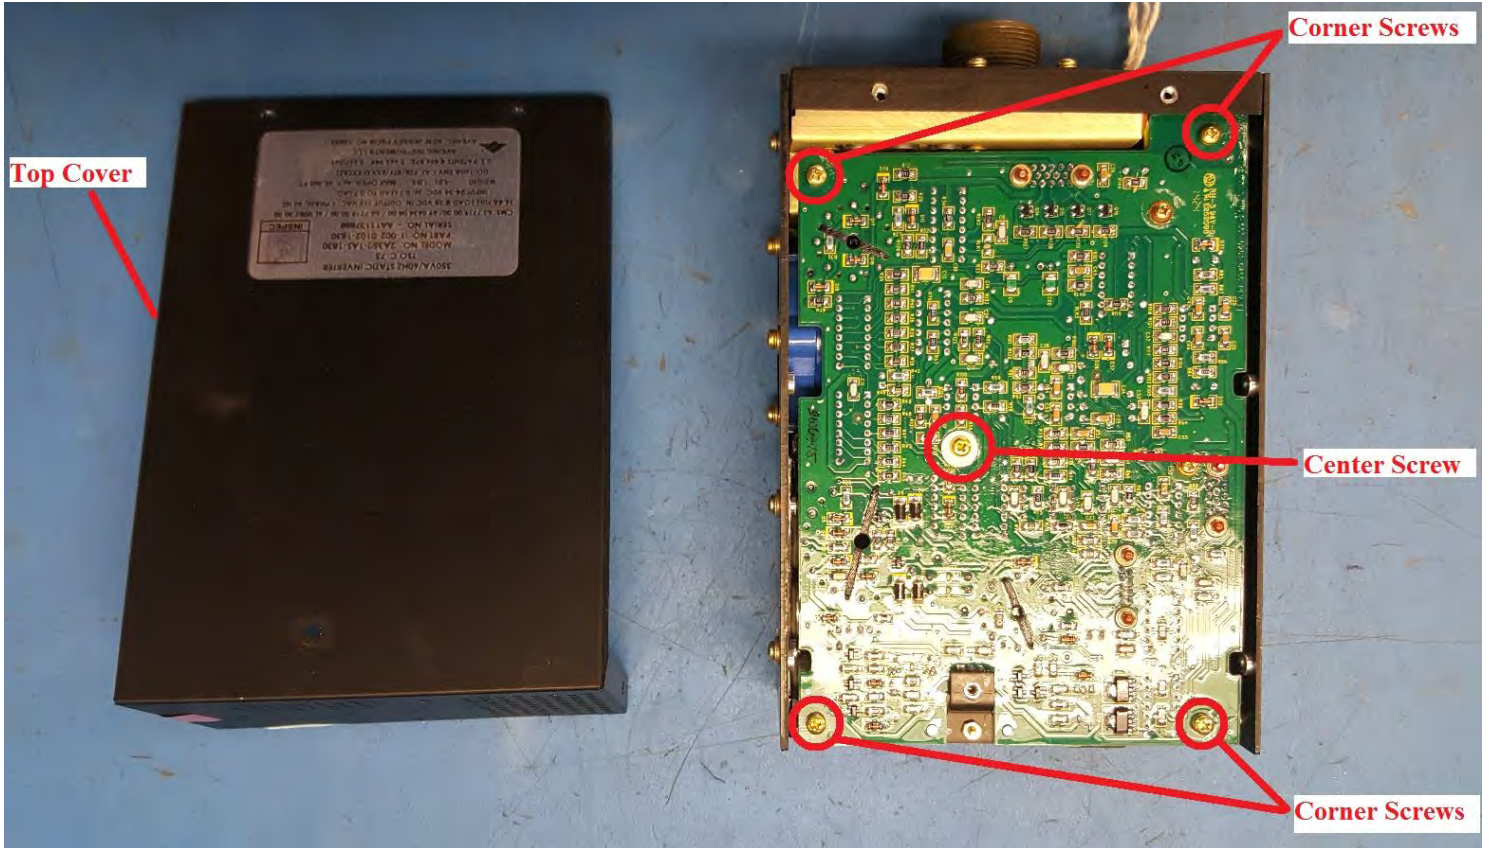
Figure 2 – Top Cover removed (PCB Screw Locations)

2. Carefully remove the top cover (Note: there may be a seal on the corners where the top cover meets the rear panel, remove this as well).
3. Remove four (4) corner screws and one (1) middle screw from the PCB. All screws in this step use washers (Figure 2).
