Service Information Letter

Notification of Product Improvement for 4C3500 High Voltage Frequency Converters

Manufacturer's Part Numbers: 4C3500-()

SIL 24-20-02

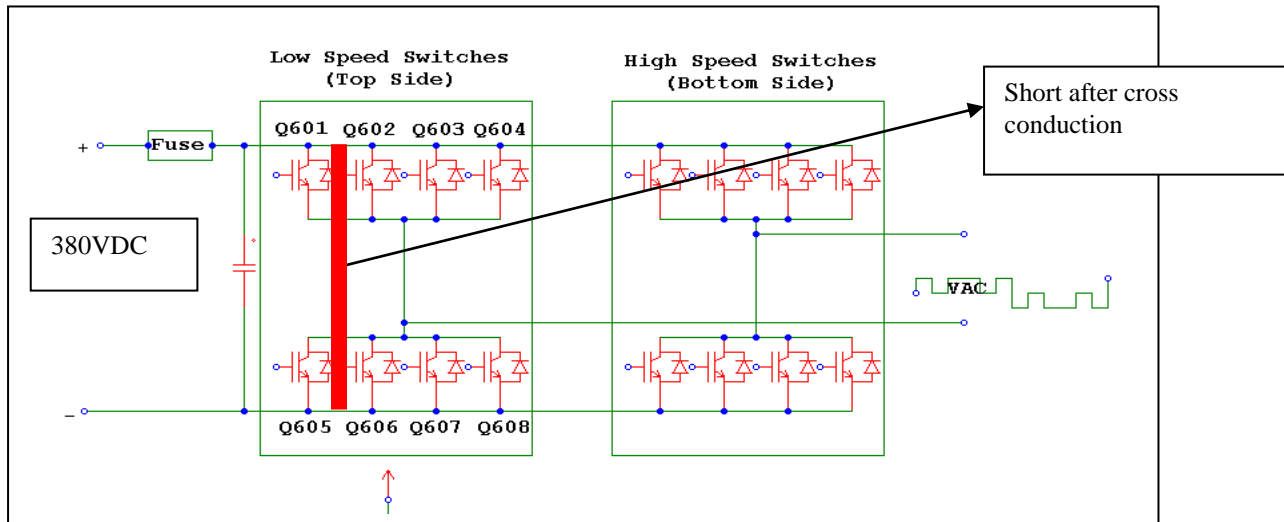
Figure 1 Bridge Assembly

Simultaneous conduction of upper & lower Low Speed Switches could result in a short circuit across the 380v DC Link voltage bus. See Figure 1 illustrating this "cross conduction event". Instantaneous power dissipation on these switches would then be excessive, exceeding the device rating. As a result unrepairable damage to the power pc board may occur, e.g., Power PC Board burnt or discolored, as well as other assemblies that are in close proximity to the power board.

To prevent high levels of damage to the power boards and the control board of the frequency converters, Avionic Instruments is upgrading the above units to Mod "J". This product improvement adds fast acting fuses for Fuse (F1) to 30A (3 10A fuses / P/N 1-001-0814-0009) which replaces the 30A single fuse which is currently being used as this enables the fuse to react more quickly to prevent damage.

Engineering testing was done with the fast acting fuses by simulating a bridge failure and the fuses opened-up before any damage to PCB's occurred. An ECN will be generated to change the fuse configuration. If there is a failure on the bridge assembly the fuse will open, removing power to the bridge and preventing further damage to PCB's.

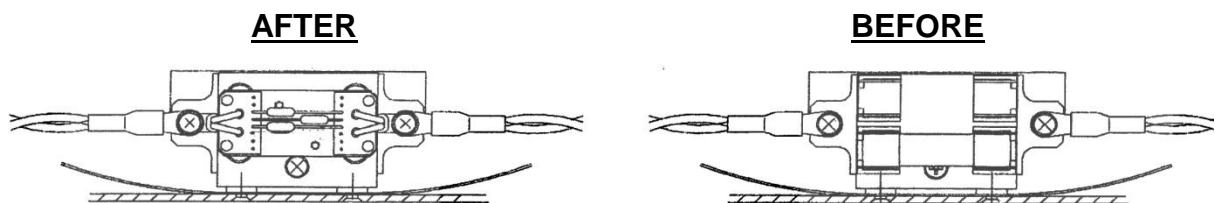
Figure 2
Fuse Configuration

End result of executing product improvement

Avionic Instruments has released this SIL to alert the fleet operators in possession of the in-service frequency converters of the potential for product improvement. This SIL contains information on a change to the fuse configuration for the frequency converters cited herein. The 30 amp fuse is being replaced with three 10 amp fuses. The modified converters will be identified as "MOD J". See Figure 2 for the before and after fuse configuration.

Delete from High Voltage type Chassis assemblies the sub assembly P/N 1-002-0113-0642 (FUSE BRACKET ASS'Y) and replace it with new assigned P/N 1-002-0113-1067 (new release...Rev-A).
